WL-TR-97-2053

THIN DENSE CHROME BEARING INSERTION
PROGRAM

GE AIRCRAFT ENGINES
ADVANCED ENGINEERING PROGRAMS DEPT
ONE NEUMANN WAY
CINCINNATI OH 45215-6301

FINAL REPORT FOR 03/01/92-12/01/96

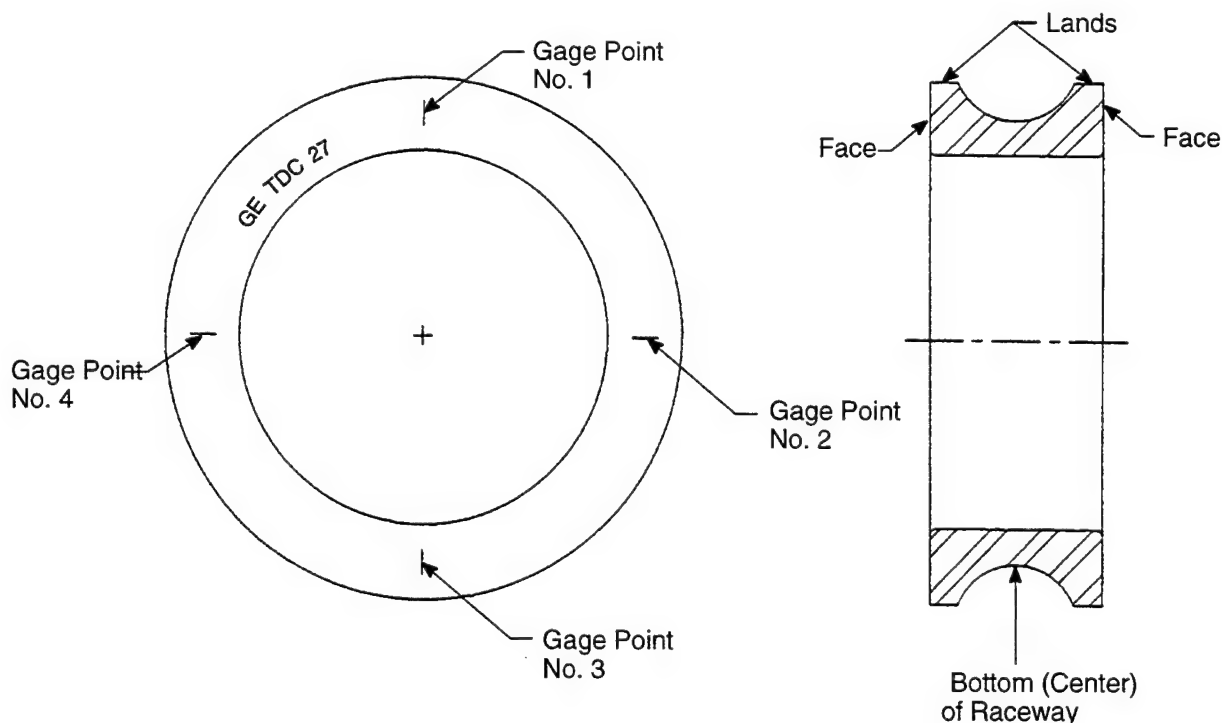
Figure 2. GE TDC 27 (MRC Round 1) Plating Thickness Measurement Locations.

The thickness of the TDC coating was also checked as a function of subscale bearing endurance rolling contact fatigue operating time in four locations as shown in **Figure 2**, with the results being shown for GE TDC 27 in **Table 6**. It is evident from this data that the wear

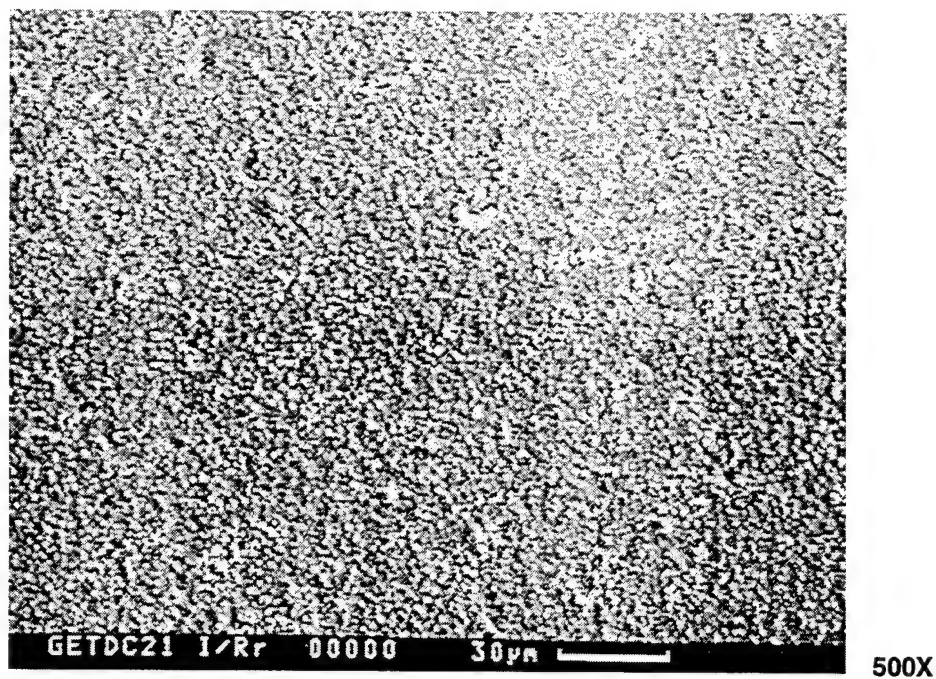
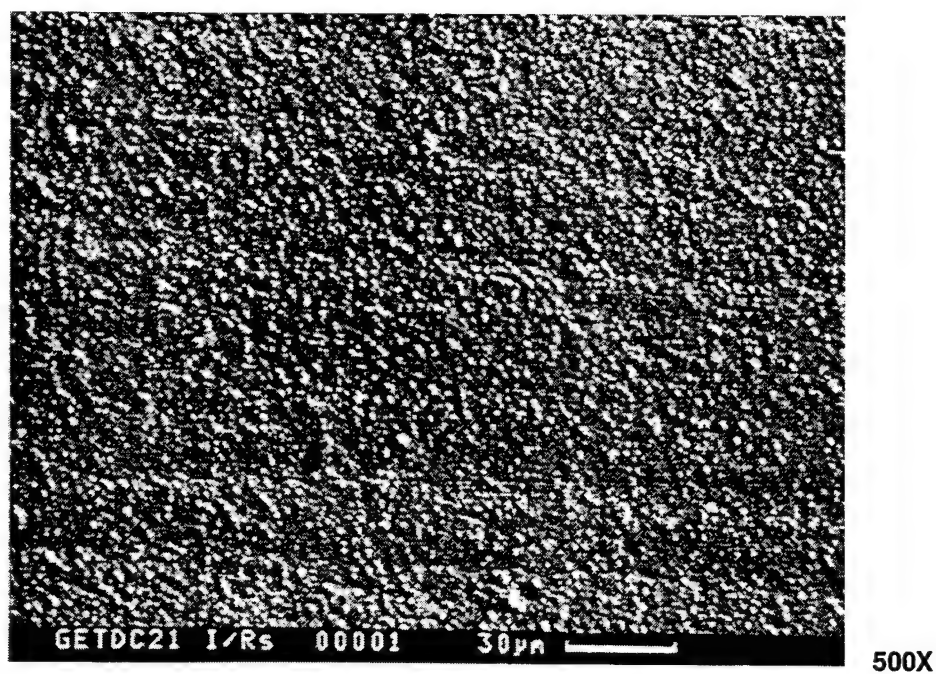
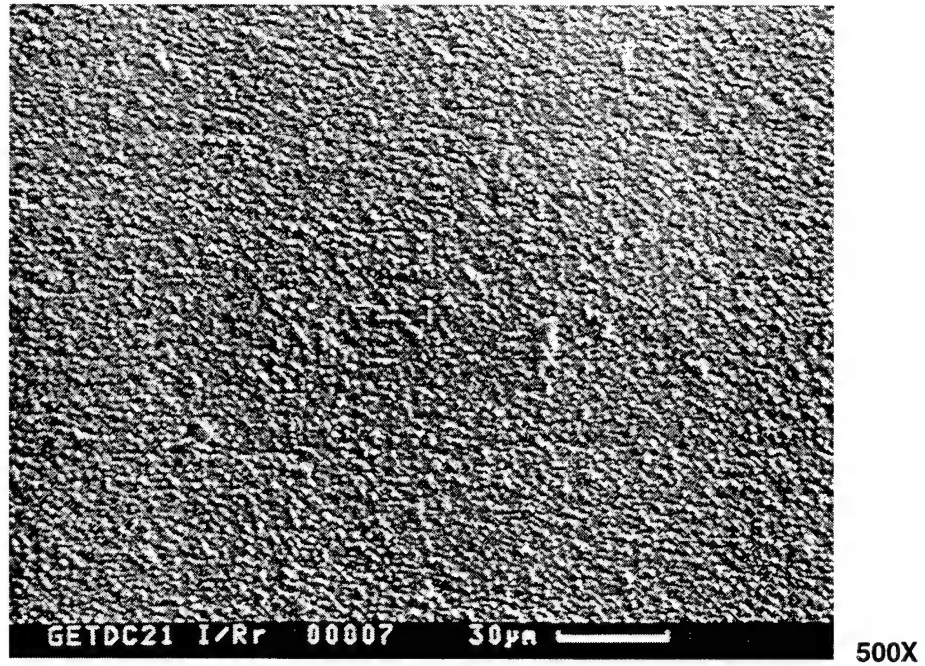
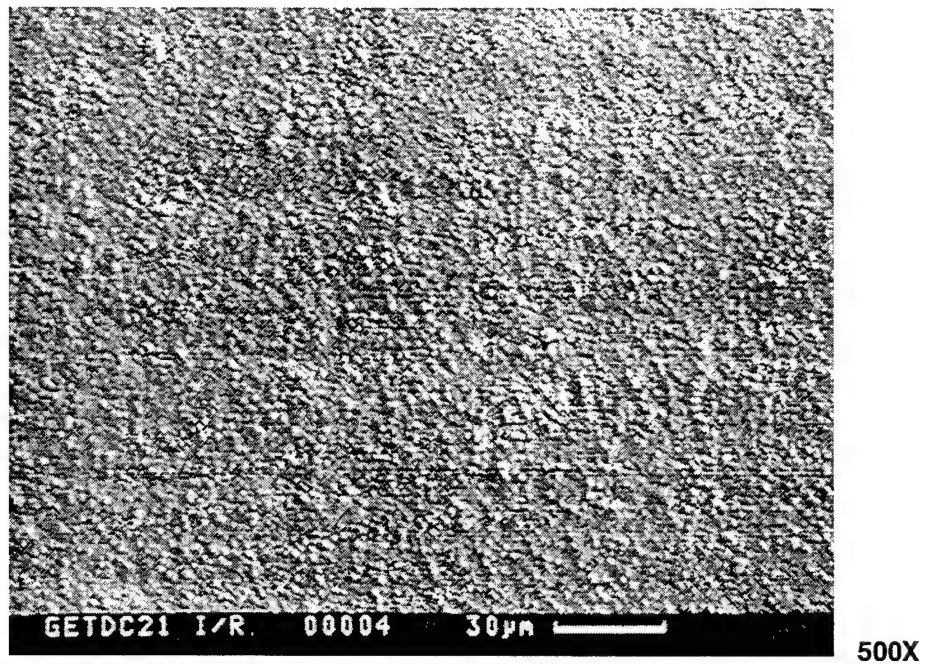
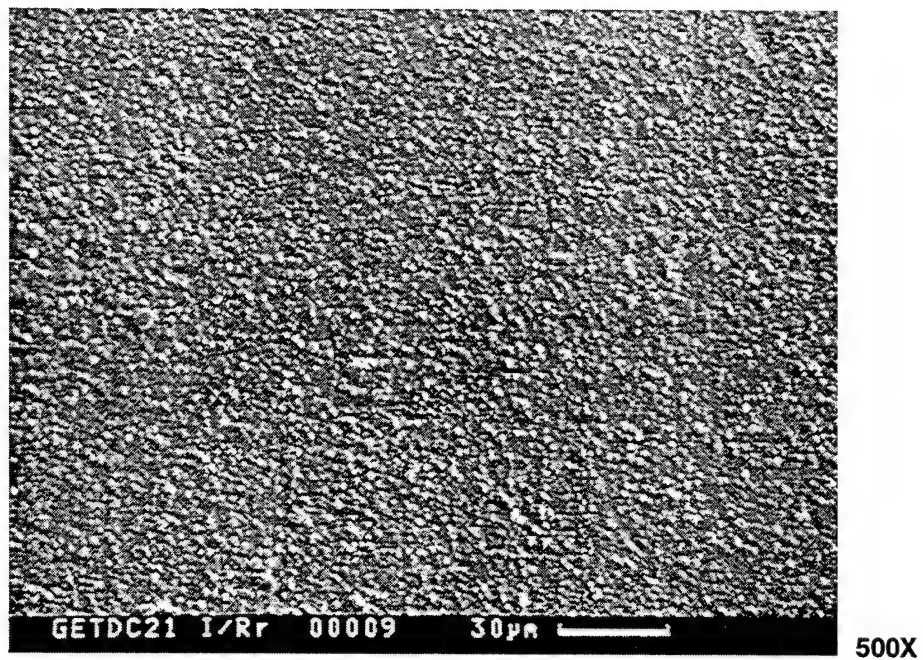
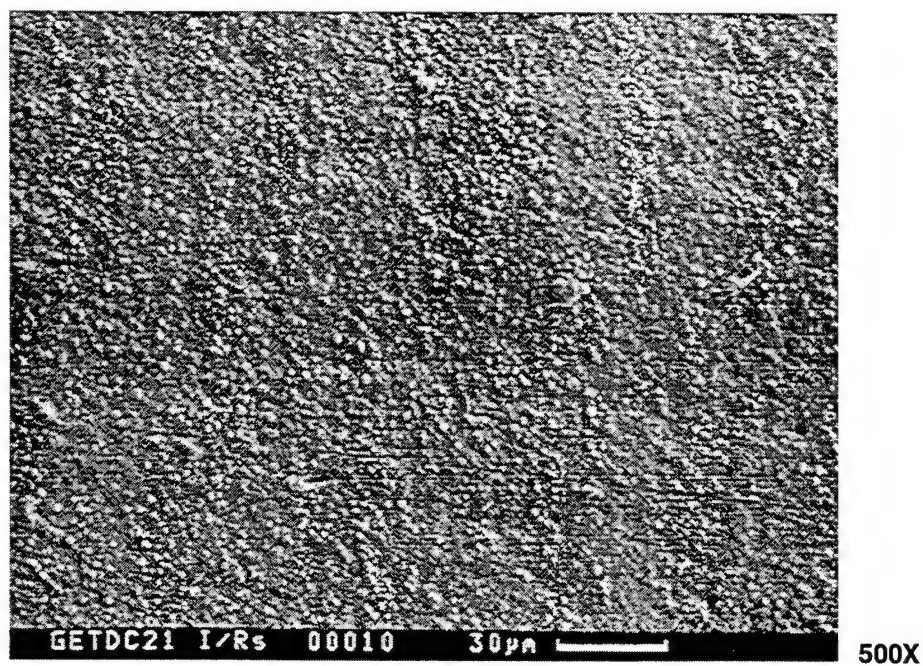
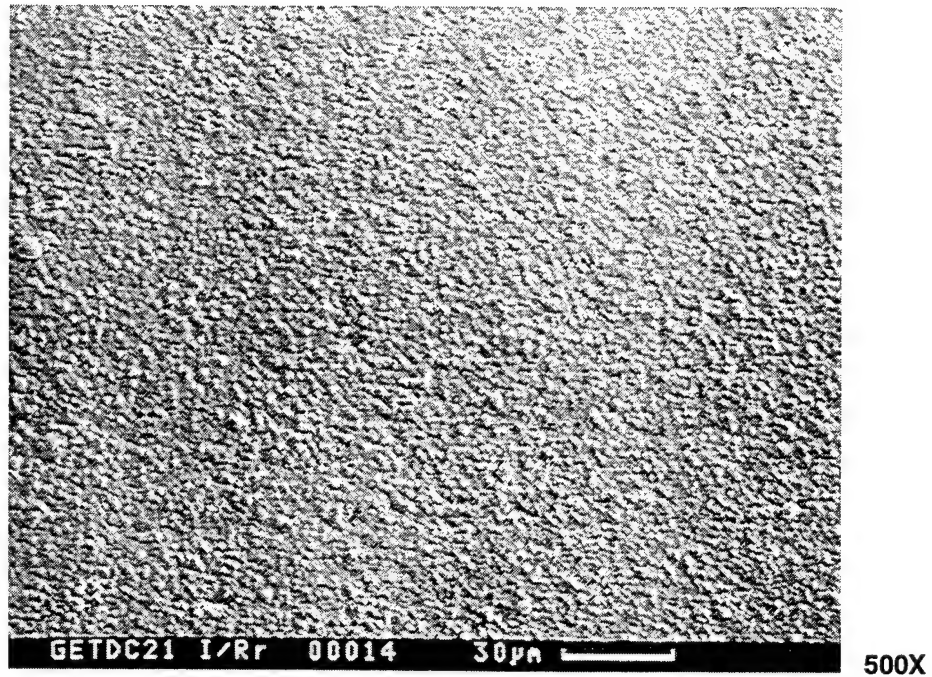
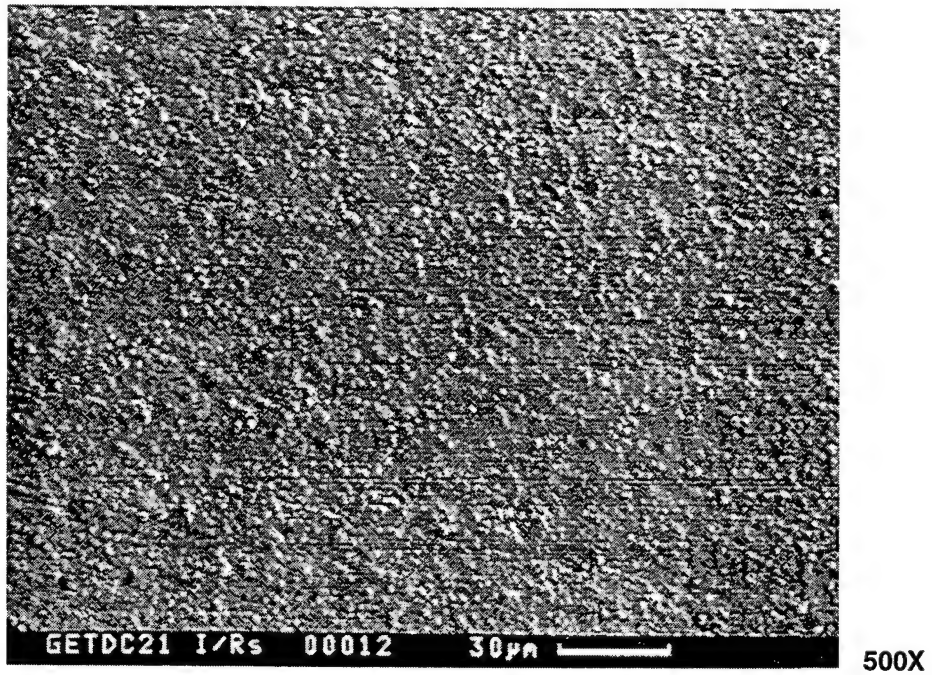
Figures 3 through 10 show the TDC topography of the raceway and shoulder in four different locations around the bearing using the scanning electron microscope (SEM) at 500X. The coating exhibits a nodular TDC without any evidence of cracking. Although this topography passed the GE specification, some variation in nodule size is evident in these micrographs.

Figure 3. SEM Quality/Topography Photo of Position 1 (0°) in Raceway. *Within spec.*

Figure 4. SEM Quality/Topography Photo of Position 1 (0°) in Shoulder. *Within spec.*

Figure 5. SEM Quality/Topography Photo of Position 2 (90°) in Raceway. *Within spec.*

Figure 6. SEM Quality/Topography Photo of Position 2 (90°) in Shoulder. *Within spec.*

Figure 7. SEM Quality/Topography Photo of Position 3 (180°) in Raceway. *Within spec.*

Figure 8. SEM Quality/Topography Photo of Position 3 (180°) in Shoulder. *Within spec.*

Figure 9. SEM Quality/Topography Photo of Position 4 (270°) in Raceway. *Within spec.*

Figure 10. SEM Quality/Topography Photo of Position 4 (270°) in Shoulder. *Within spec.*

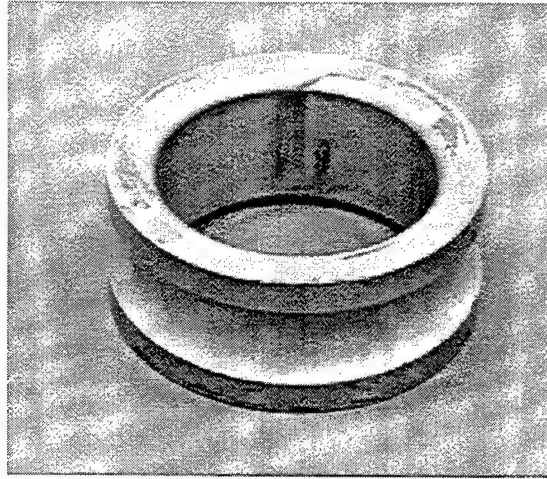
The tested bearing is shown in Figure 11. The staining which is evident on the bearing came from stamp marks, vibration peen marks, and

Figure 11. Photo of Inner Ring from 24-Hour Salt Spray Test (MRC Round 1).
Although the ball track was free of corrosion, a few isolated areas did corrode resulting in the staining evident in the photo.

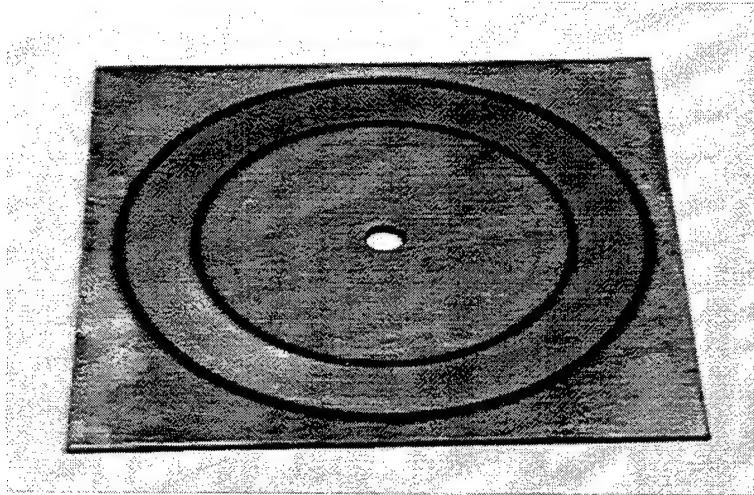
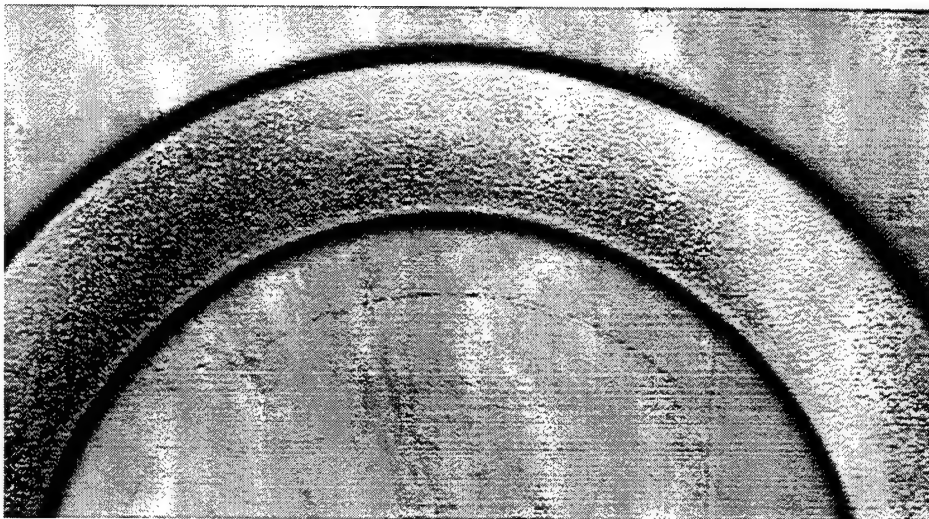
Taber wear data indicates a wear index of 0.2 (an average of 1.0 milligram weight loss) for the three specimens tested. This is considerably less than the requirement of a wear index 1.2 or less. **Figure 13** shows a typical posttest specimen. The test machine used was at Bridgeport Testing Laboratory. The test certification is included in Appendix A.

Figure 13. Photos of Taber Wear Test Specimen.
Specimen wear of 0.2 was well below the upper wear index limit of 1.2.

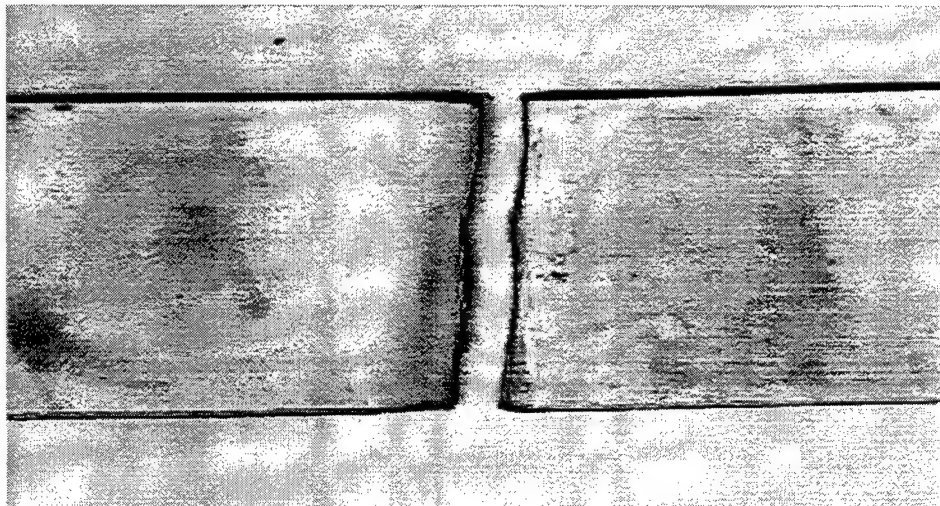
Figure 14 shows the panel used in the bend test performed by Armoloy of Connecticut. Post-bend test inspection indicated that the TDC coating adhered to the base metal, and did not flake, peel, or delaminate.

Figure 14. Photos of Bend Test Specimen.
TDC did not flake, peel, or delaminate.

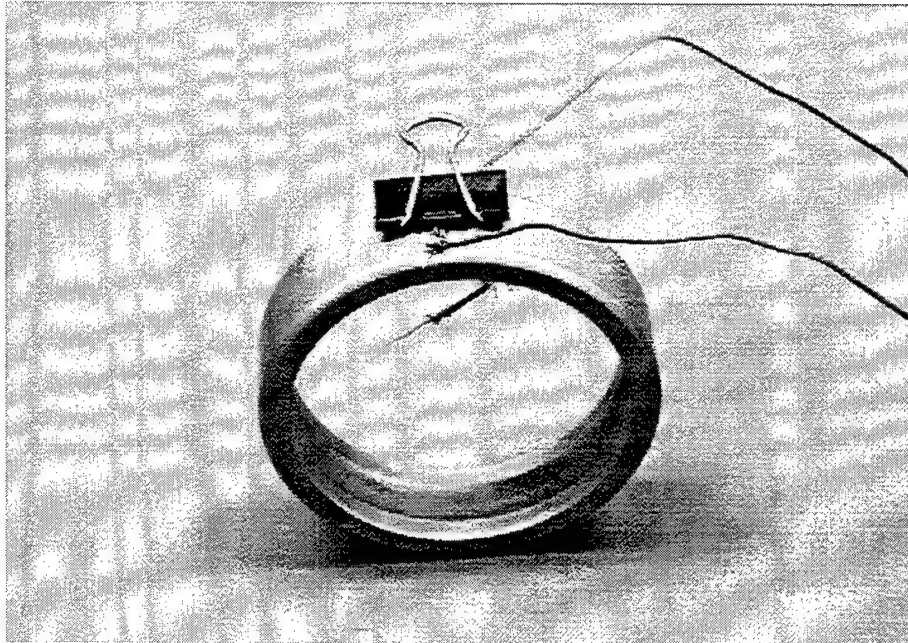
Postthermal shock inspection showed no evidence of cracking or peeling of the TDC, although a few small discrete areas of staining (discoloration) were evident. The discoloration or staining was probably caused by water condensation on the bearing. In particular, in any pits or cracks in the TDC coating in the few areas noted. This condensation in turn likely caused a small amount of corrosion in those few areas which appear as staining or discoloration upon visual inspection. **Figures 15** through **18** show the test specimen with attached thermal couple leads, in the quench chamber, liquid nitrogen tank and data acquisition system, and in the oven used throughout this testing. **Figure 19** shows the temperature profile traces of the 10 thermal cycles used in this experiment. **Figures 20** through **35** show the TDC surface post-thermal shock for the two bearing rings used in this evaluation. The TDC appears to be generally free of any cracking or delamination and appears to be in good condition at all positions.

Figure 15. Photo of Bearing Outer Race Used in Thermal Shock Test.
Thermocouples were used to monitor test temperature.

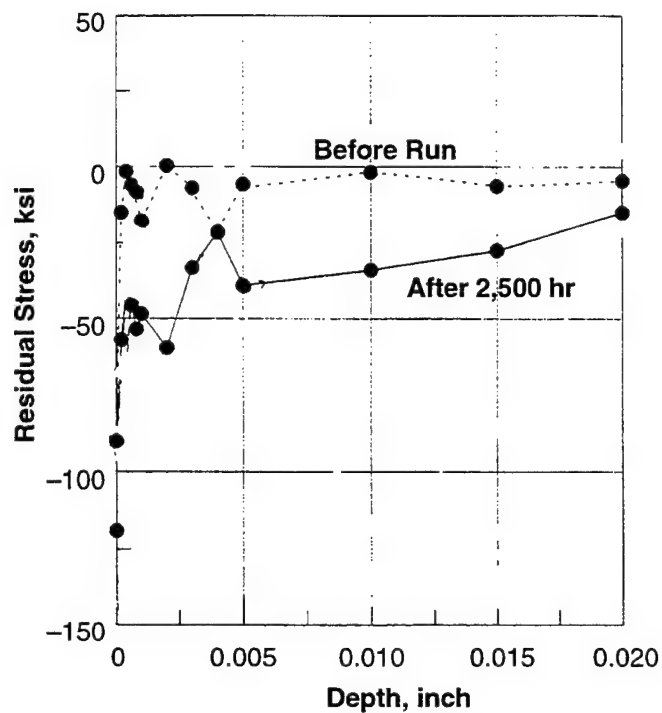
Residual stress profiles of plain and TDC coated bearing inner rings after 2,500 hours of endurance testing, as shown in **Figures 37** and **38** indicated both a large residual compressive stress in the area of the 0.010in deep for the TDC coated and a smaller and shallower (≈ 0.005 in deep) subsurface compressive stress for the plain bearing. Since the depth of maximum shear stress is proportional to the contact area which in turn is proportional to the applied load and inversely proportional to the modulus of elasticity, it was concluded that the TDC bearing was either operating at a higher load, at a higher contact temperature, or both.

Figure 37. Residual Stress Profiles of MRC Round 1 Bare Baseline Rings. *Note the degree of change between the before and after the 2,500 hours is small when compared to the profile of the TDC coated bearings shown in Figure 38.*

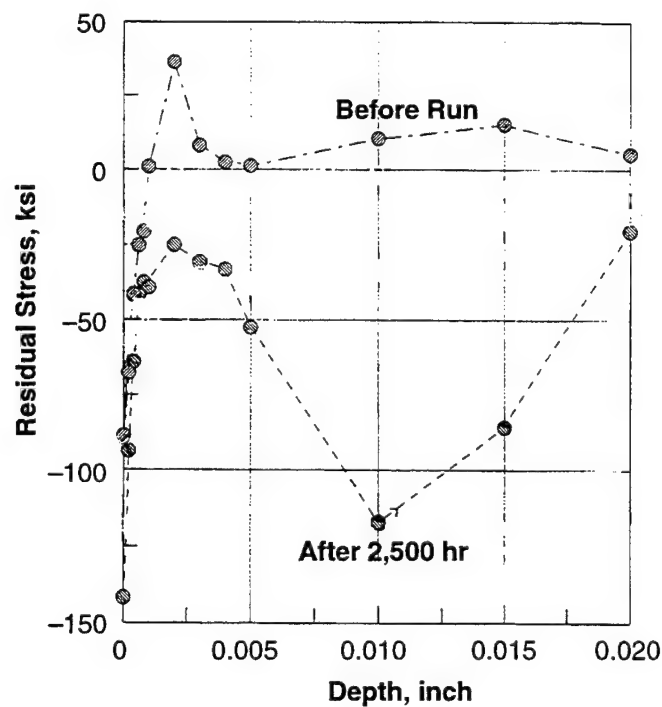
Figure 38. Residual Stress Profiles of MRC Round 1 TDC Coated Rings. *Note the Large compressive stress at 0.010 inch deep as a result of the 2,500 hours of operation.*

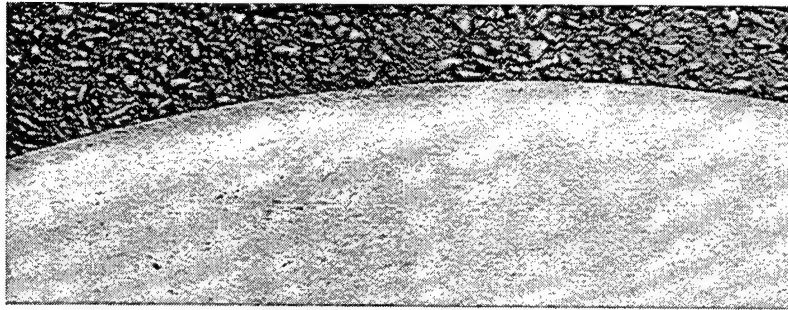
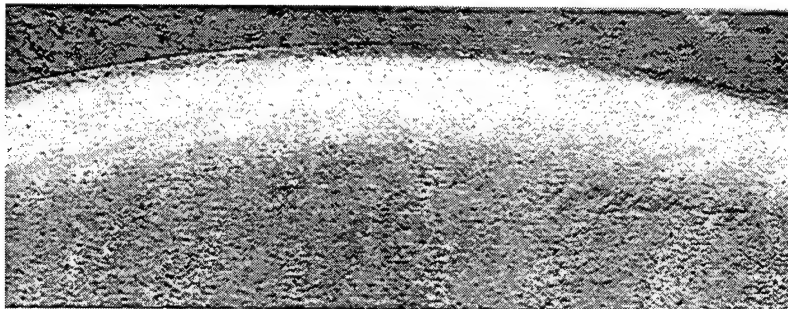
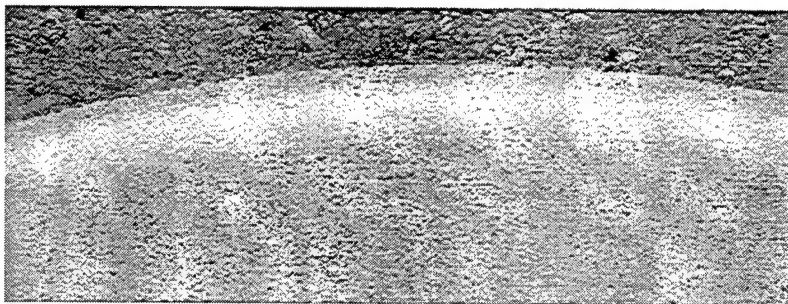
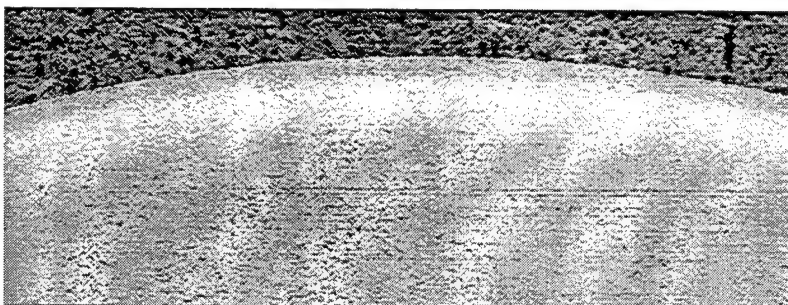
An examination of the M50 balls from both the TDC plated bearings and the plain bearings revealed a larger amount of stress induced microstructural alterations (white etching microstructure) at the maximum shear depth in the TDC plated bearings than in the plain bearings. This is further evidence that the TDC bearings were operating at a higher load, higher temperature, or both. **Figure 46** shows the

white etching regions in the TDC plated bearings and **Figure 47** in the plain bearings.

contact temperature, lowering the materials modulus and strength, driving the maximum shear stress deeper, and allowing it to cause microstructural alterations. Additionally, higher heat generation may cause the inner ring to heat up more than the outer ring forcing the loss of radial clearance, as was observed in the TDC coated bearings.

Figure 46. Optical Micrograph of MRC Round 1 TDC Test Balls.
Note white etching layer in max. shear zone.

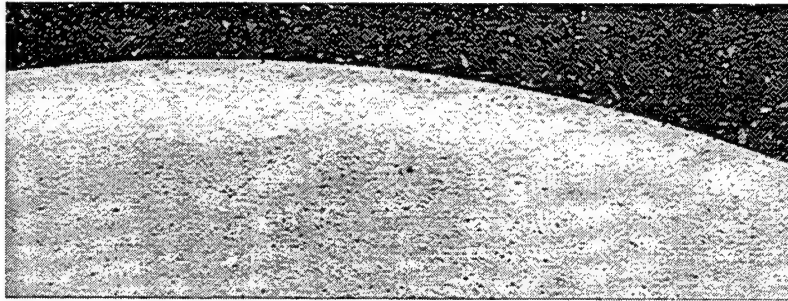
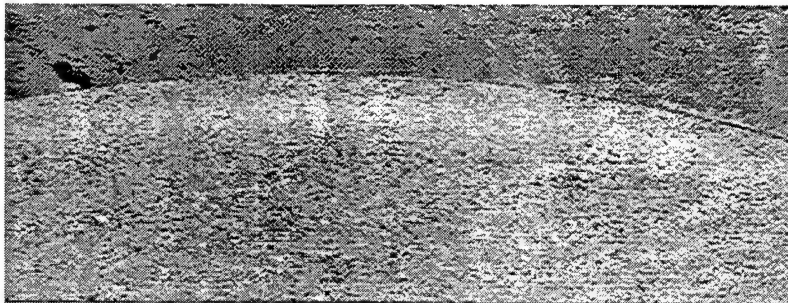
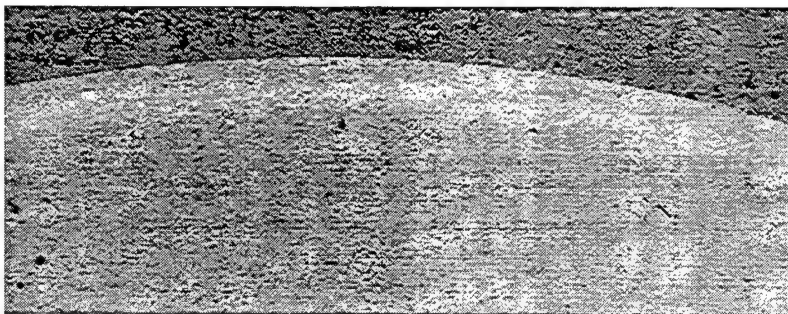
Figure 47. Optical Micrograph of MRC Round 1 Plain Test Balls.
Note lesser amount of white etching layer compared to balls from coated bearing balls, Figure 46.

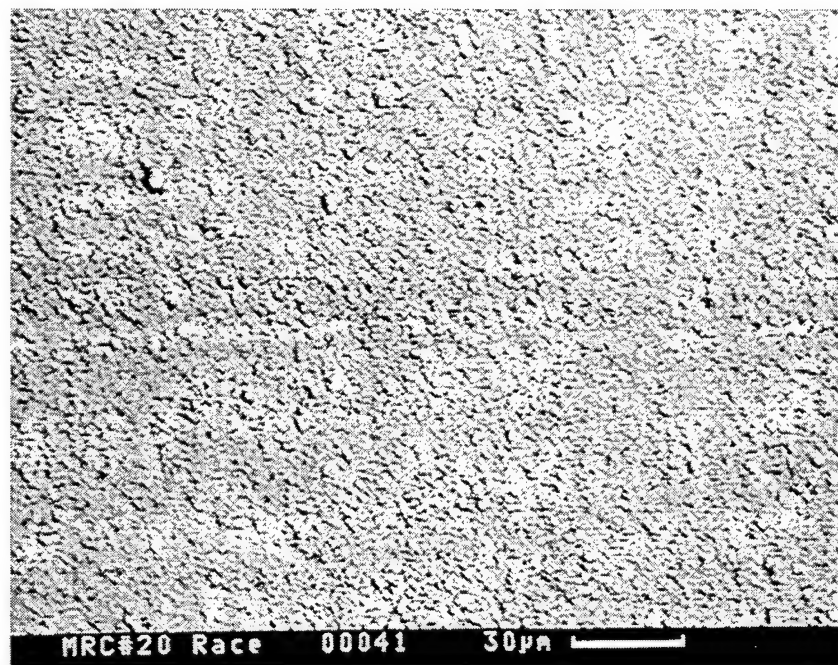
Scanning Electron Microscope inspection of an inner ring GE TDC 20 (**Figures 48 through 51**) indicated that the TDC coating lacked the typical well rounded nodules in the ball track and

Figure 49. SEM Photo of Bearing Raceway, BEI Mode. *Note lack of typical TDC nodularity.*

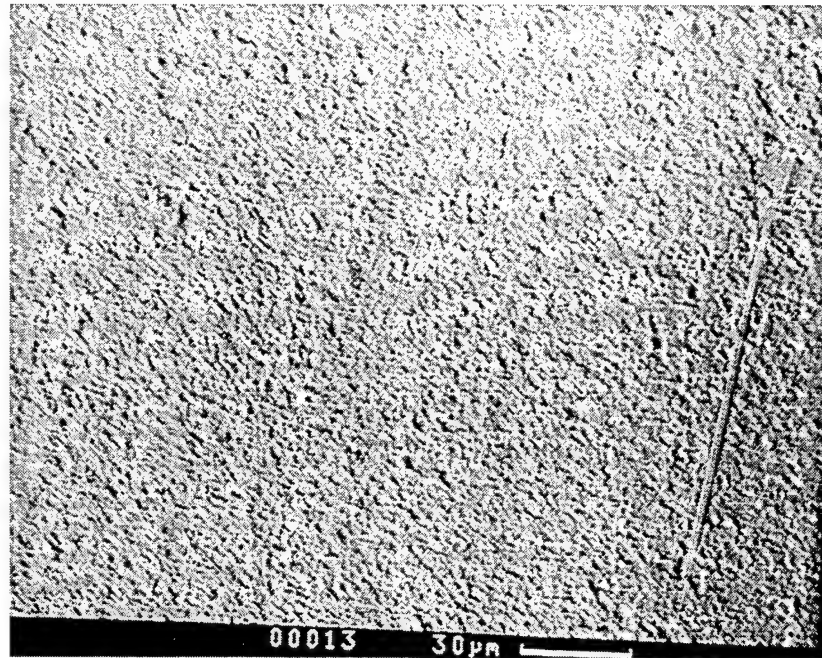
500X

Prior to testing, inner ring GE TDC 31 was evaluated on the SEM to determine if it contained cracks as was seen in S/N 20. **Figures 52 through 61** show the topography of this bearing. Cracks were evident at the edge of the raceway track and the edge of the land. Upon completion of the 24-hour salt spray testing, numerous rust spots appeared on this specimen (**Figure 62**) and it was deemed to have failed this test. This result was also confirmed with inner race GE TDC 18. It contained a similar amount of corrosion after a salt spray test. The amount of corrosion in Round 2 was considerably greater than that exhibited in Round 1. Test results are in Appendix B.

Figure 52. SEM Photo of Center of Bearing Raceway, SEI Mode.
Note lack of nodularity.

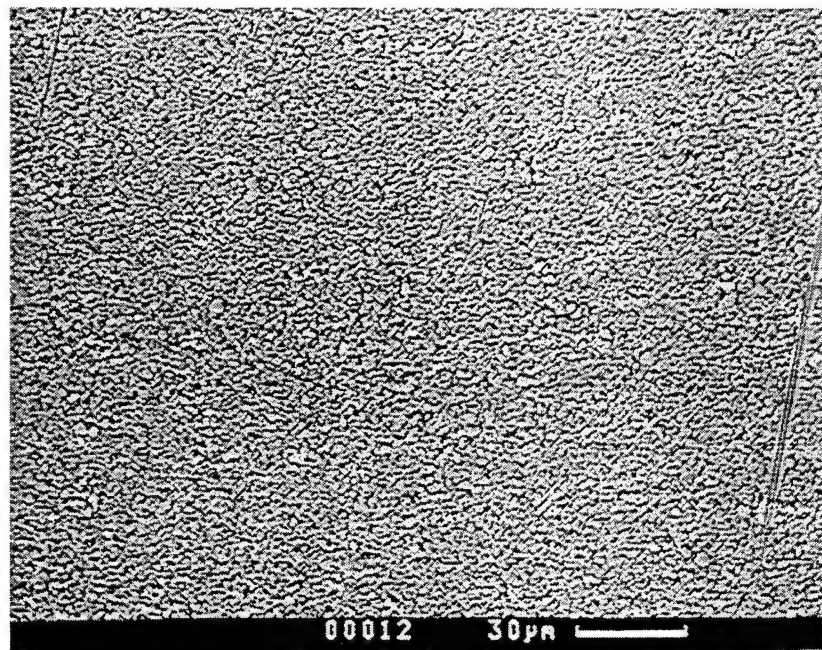
500X

Figure 53. SEM Photo of Center of Bearing Raceway, BEI Mode.
Coating is intact in this area.

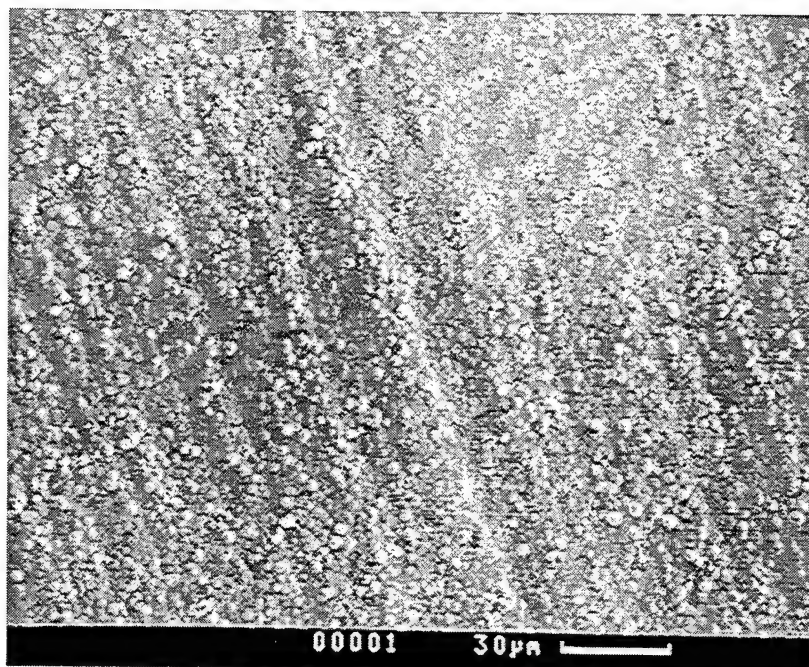
Figure 58. SEM Photo of Center of Land No. 1, SEI Mode.

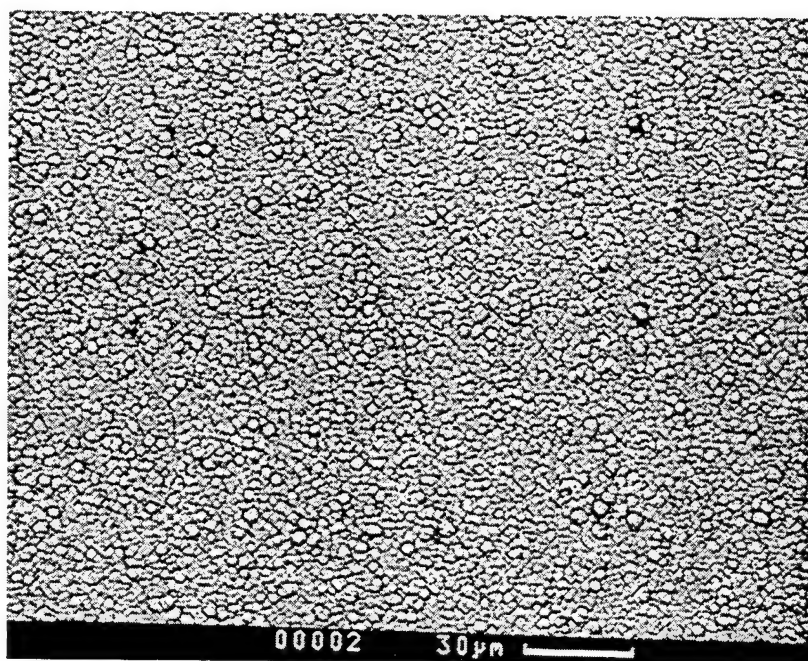
Figure 59. SEM Photo of Center of Land No. 1, BEI Mode.

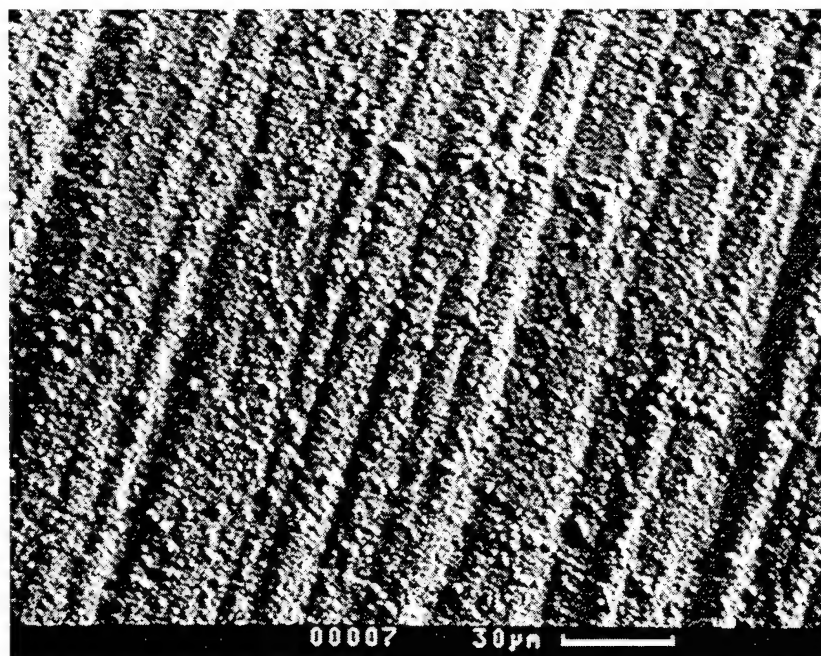
Figure 60. SEM Photo of Center of Land No. 2, SEI Mode.

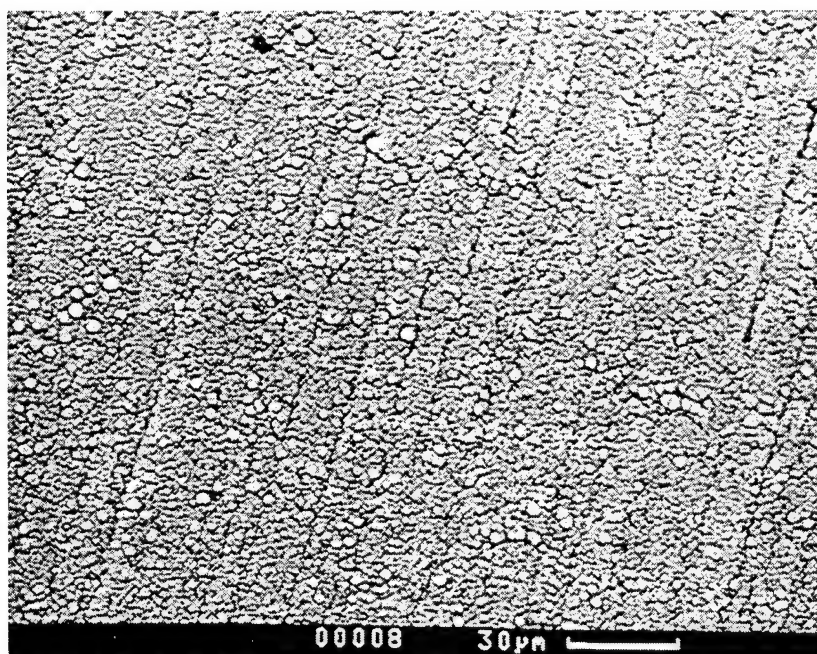
Figure 61. SEM Photo of Center of Land No. 2, BEI Mode.

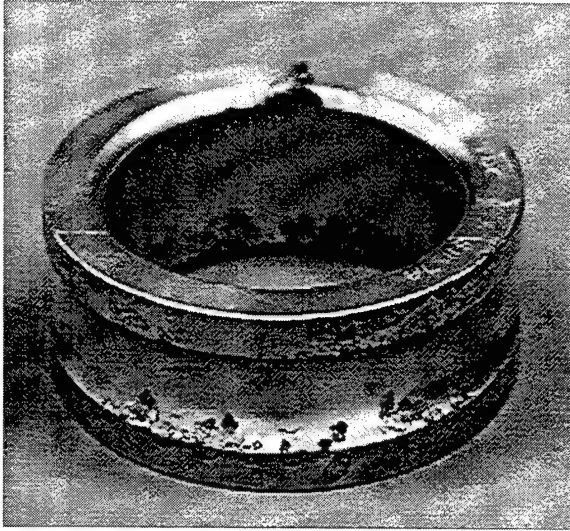
Figure 62. Photo of GE TDC 31 Inner Ring Corrosion after Salt Spray Test. Note large amount of rust.

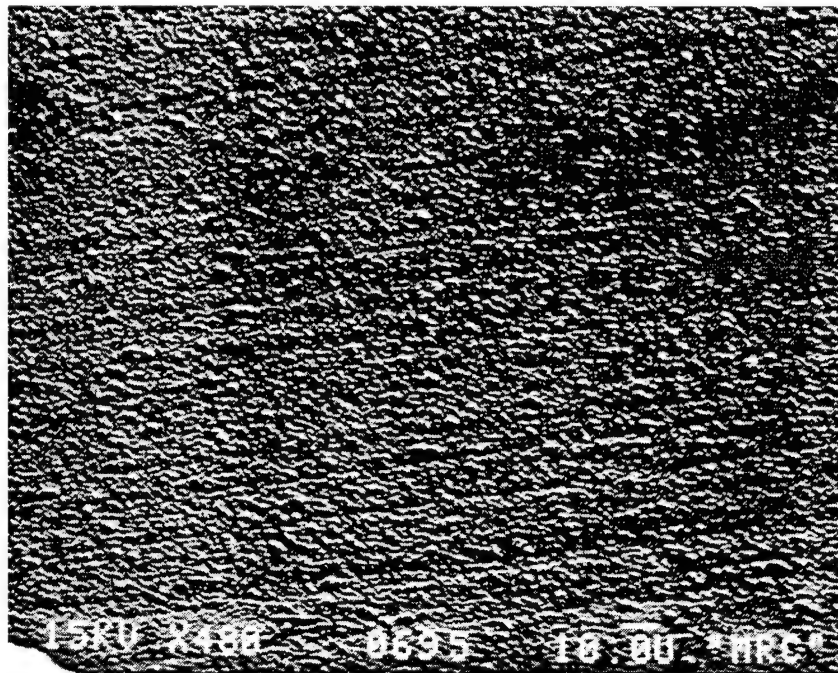
Figure 63. SEM Photo of Raceway, 0°. *Note lack of nodularity.*

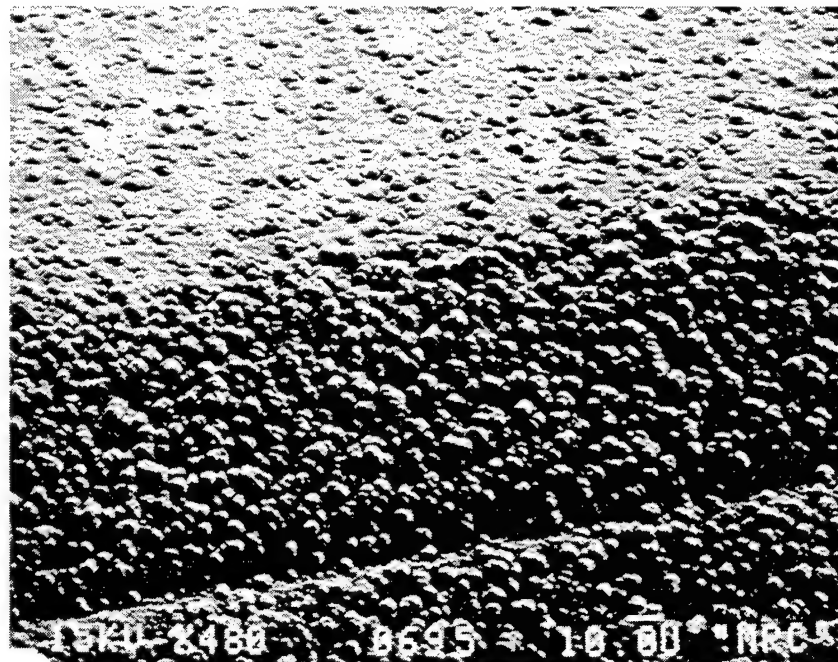
Figure 64. SEM Photo of Race/Land Edge, 0°. *Note mix of nodularity, both flat and nodular areas exist in the race/land edge.*

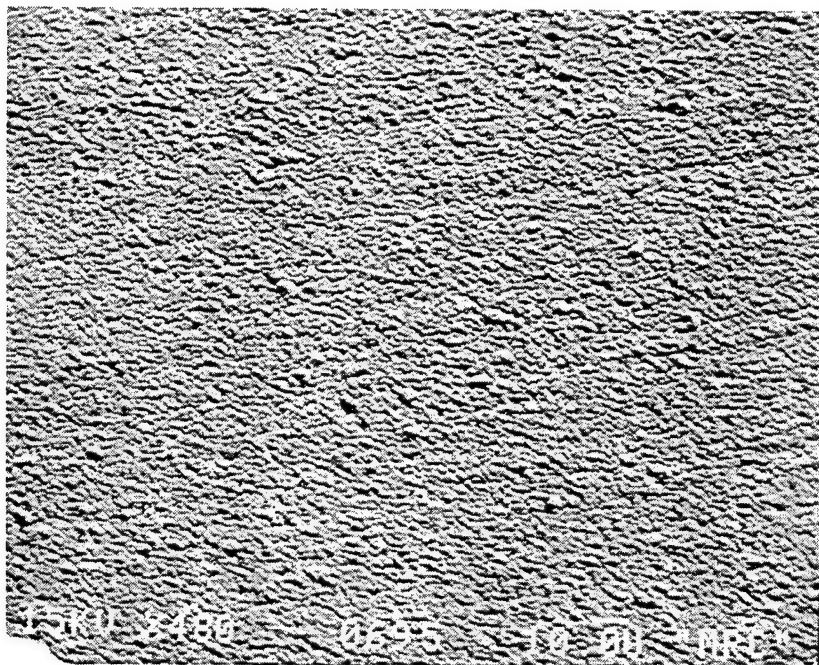
Figure 65. SEM Photo of Raceway, 90°. *Note lack of nodularity.*

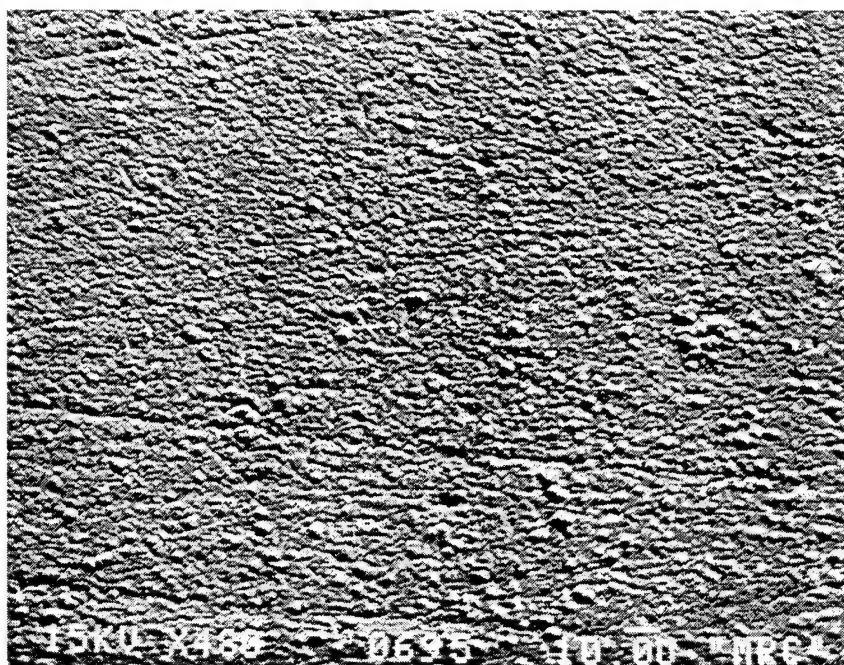
Figure 67. SEM Photo of Raceway, 180°. *Note lack of nodularity.*

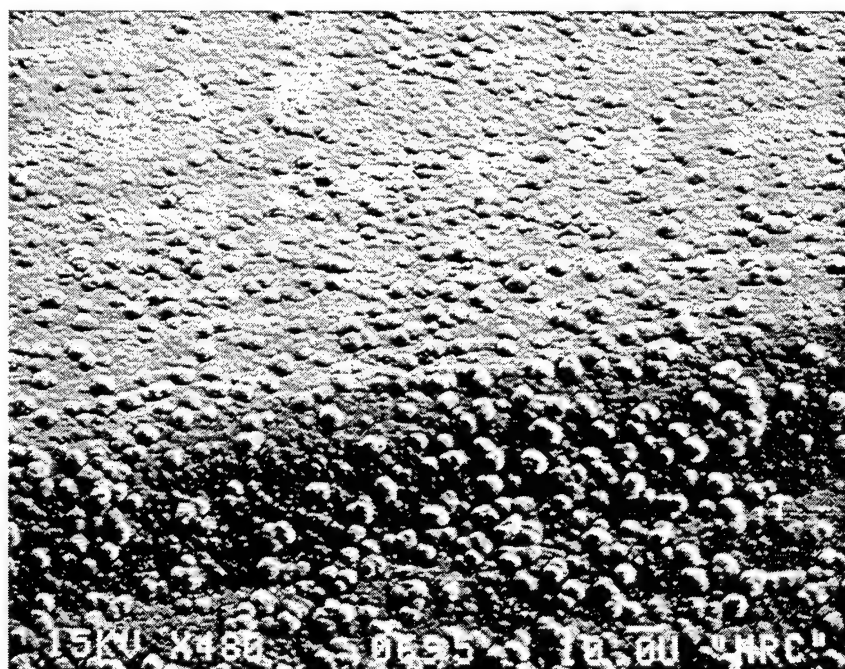
Figure 68. SEM Photo of Raceway, 180°. *Note chrome nodules on top of a relatively flat surface.*

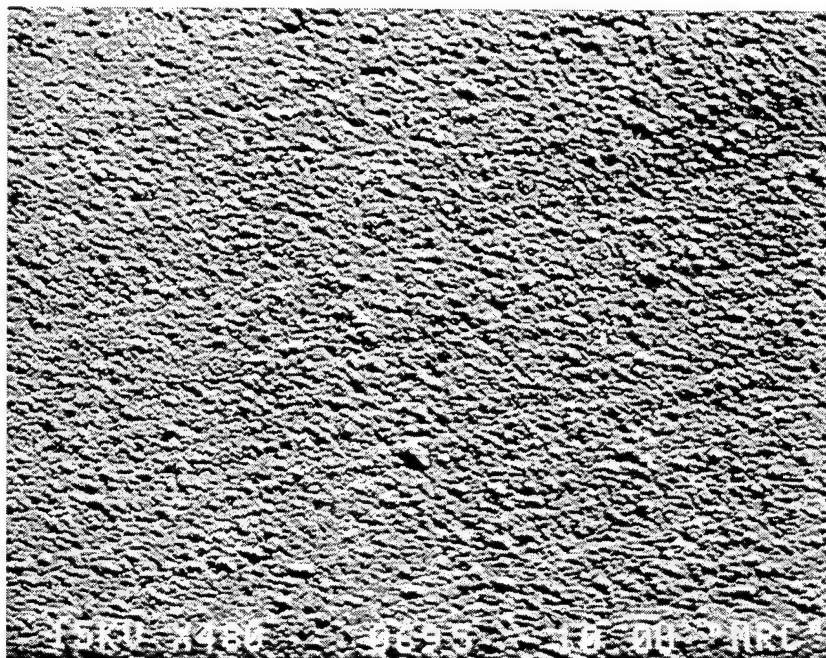
Figure 69. SEM Photo of Raceway, 270°. *Note lack of nodularity.*

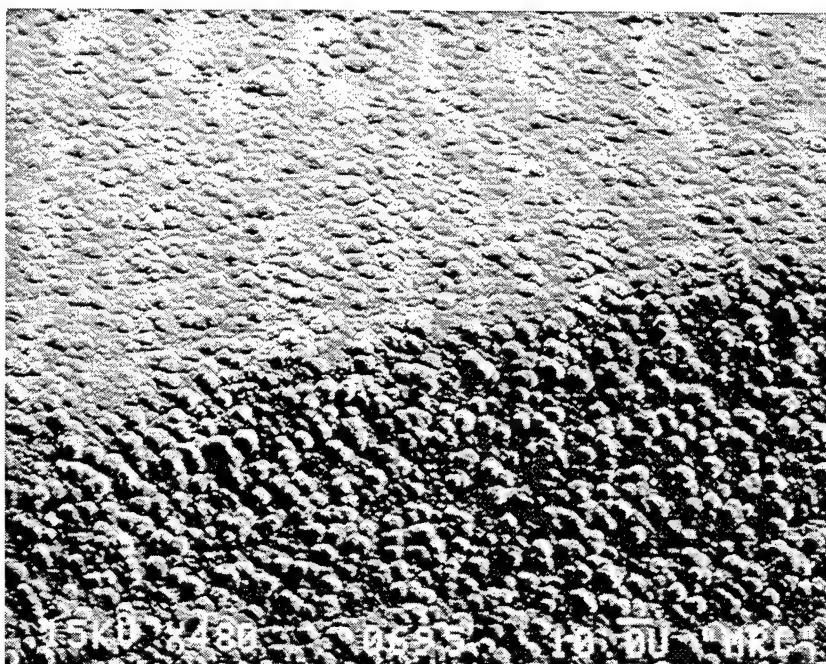
Figure 70. SEM Photo of Race/Land Edge, 270°. *Note chrome nodules on top of a relatively flat surface.*

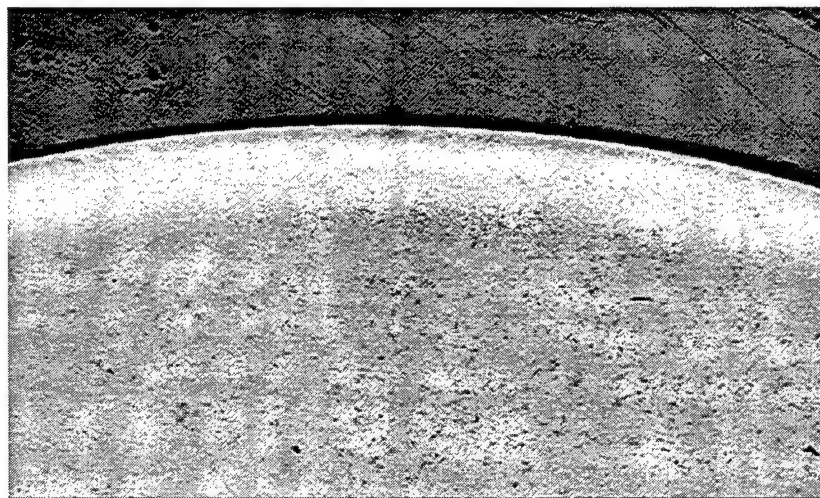
A comparison of balls from four suspended (2,500 hour) bearings to the balls from the Round 1 plain and TDC-coated bearings (**Figures 46 and 47**) indicated that the Round 2 stress induced microstructural alterations were between the two Round 1 bearings, looking more similar to balls run in the TDC coated races. However, none of the balls from the second round, **Figures 71 through 74**, exhibited as much of a white layer as did the Round 1 TDC 7 ball. This would indicate that although opening up the bearing clearance in Round 2 helped the rolling contact fatigue results, there is still some unique aspect of the TDC coating which appeared to increase either the stress or operating temperature of the bearings above that of the plain bearings.

Figure 71. Subsurface Stress Induced Microstructural Alteration (White Layer) in Ball from Round 2/Test 1. *The layer covered the entire ball indicating the ball was spinning.*

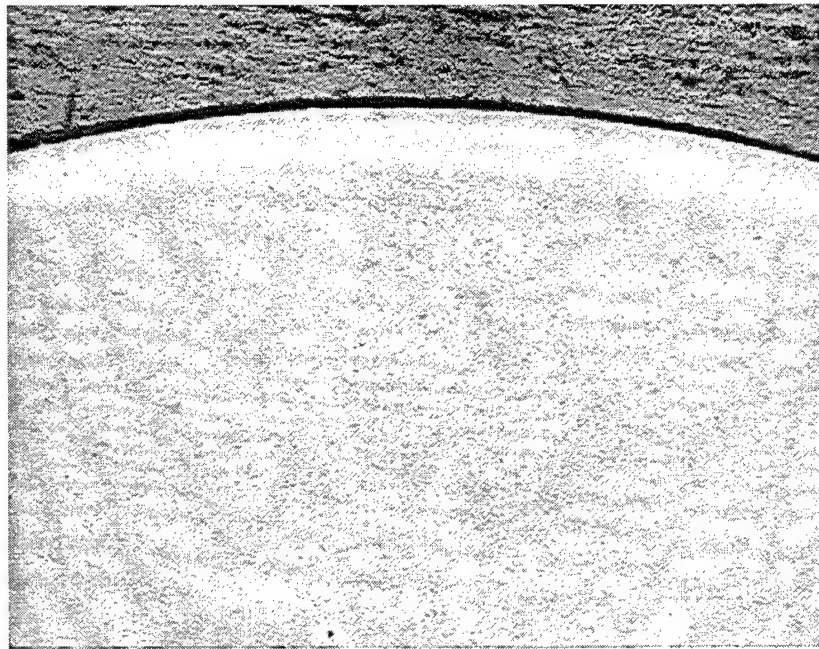
Figure 74. Subsurface Stress Induced Microstructural Alteration (White Layer) in Ball from Round 2/Test 11. *The layer covered the entire ball indicating the ball was spinning.*

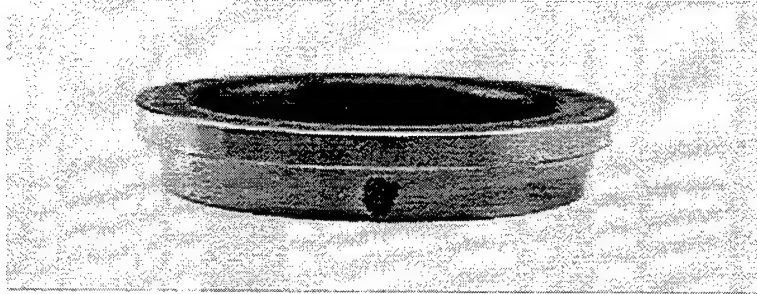
Two baseline (bare M50) failures occurred, one at 620 hours and the other at 4,030 hours. Five TDC coated bearings failed at 41, 225, 1,825, 2,293, and 2,710 hours. All failures were inner ring spalls. The estimated L10 calculation for the population based on this experiment was 2,943 hours for the baseline bearings and 519 hours for the TDC coated bearings. The TDC coated bearings L10 life clearly appeared inferior in RCF to the unplated baseline bearings. Figures 89 through 95 show both the failed baseline and TDC coated inner rings from this round of testing.

Figure 89. Photo of Plain Bearing Spall Which Failed at 619 Hours.
Only plain bearing to fail within 2,500 hours.

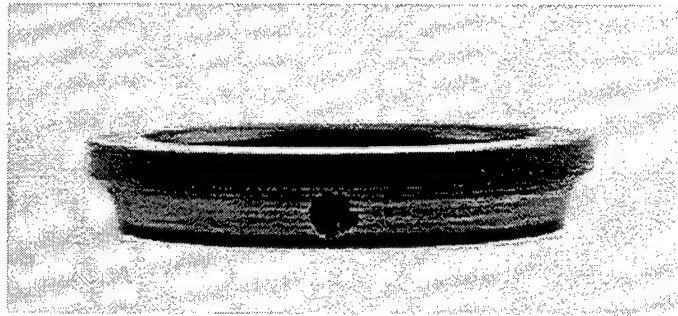
Figure 91. Photo of TDC Coated Bearing Spall Which Failed at 41 Hours.
One of five failures.
